HALIM PERDANAKUSUMA AIRFIELD.
INDONESIA

NATIONAL PHOTOGRAPHIC INTERPRETATION CENTER		PHOTO INTERPRETATION BRIEF	
Title: Halim Perdanakusuma Airfield, Indonesia	Geo Coords: 06-15S 106-54E NPIC Target No: 0982-1	Publication No: NPIC/R-1492/63 2: Date: September 1963	5X1A

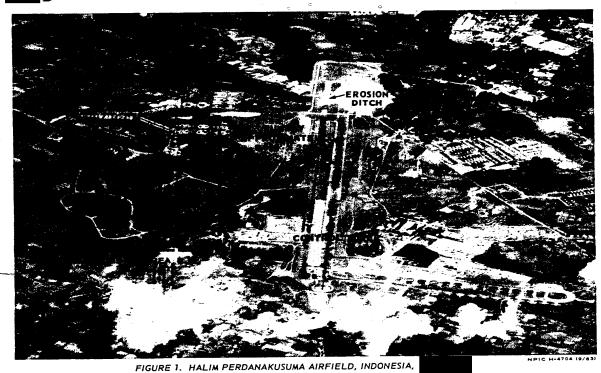
Halim Perdanakusuma Airfield, a major AURI base situated 6 nm SE of the center of Djakarta and 0.7 nm west of Pangkalan, comprises the airfield and a SAM holding area.

The airfield has an approximately 8,000 x 200 ft ENE/WSW probably asphalt, serviceable runway. In an erosion ditch was observed across the runway approximately 700 ft from the WSW end. Photography of 1/ showed the runway in a late stage of

Facilities include 3 large and one mediumsized hangar with concrete aprons at each end, a control tower, numerous barracks and support buildings, a parallel taxiway, and 2 approximately 4,400 x 190 ft NNW/SSE taxiways with a total of 24 hardstands.

The SAM holding area, situated immediately south of the airfield, contains 2 radar pads (one with a Token-type radar and 2 vans and the other unoccupied), a loop road with

18 SA-2 missile launchers, 5 vans, 3 possible vans, and 15 unidentified objects in one of 6 revetted hardstands. Four quonset huts, 4 probable storage buildings, and approximately 6 associated buildings were observed in the holding area. Photography of revealed no change in the amount of equipment.
